1st Inspection Svcs

Home Inspection Report

123 Tester Drive, Palatka, FL 32177
Inspection prepared for: Test Demo
Date of Inspection: 10/14/2019 Time: 10:00
Year Built: Circa 1958 Size: 1540
Weather: Fair

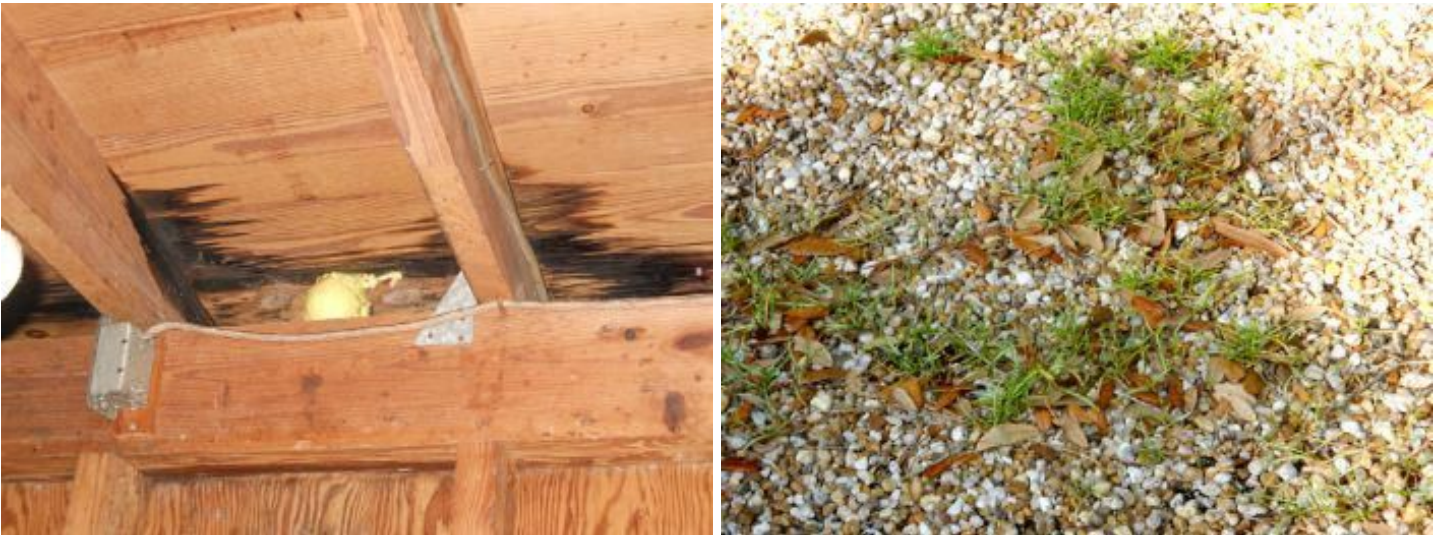
- 3.1. The vents and flashing appeared to be in serviceable condition and properly sealed at the time of this review, however, the periodic resealing of the flashing may be expected as part of routine maintenance.
- 3.2. **Edge meta** was in satisfactory condition and intact with any exceptions noted..
- 3.3. We noted moisture stains on the roof **creaking** in the utility room. Recommend further evaluation and repair by a licensed roofing contractor.
- 3.4. Vegetation was growing on the roof.

Sheathing moisture stains in utility room

Roof		
Page 3 Item: 3	Roof Material	3.3. We noted moisture stains on the roof sheathing in the utility room. Recommend further evaluation and repair by a licensed roofing contractor. 3.4. Vegetation was growing on the roof.
Foundation & Grading		
Page 5 Item: 4	Grading	4.1. Siding to Soil contact or proximity. This may provide entrance of moisture or insects to siding. Recommend grading soil so there is at least 6" of space (where practical) between the siding and the soil below and checking for any damaged trim and siding materials.
Exterior		
Page 6 Item: 2	Exterior Walls	2.1. Loose trim board noted at west elevation 2.2. There are a few openings on the exterior walls. We recommend these be sealed as to prevent pest intrusion.
Page 6 Item: 6	Soffit & Fascia	6.2. Minor moisture damage noted on west elevation at the power mast.
Interior		
Page 8 Item: 3	Windows & Doors	3.5. Exterior door screen in the Florida room is damaged. 3.6. Master bath door is missing. 3.7. We noted two jalousie window panes were missing.

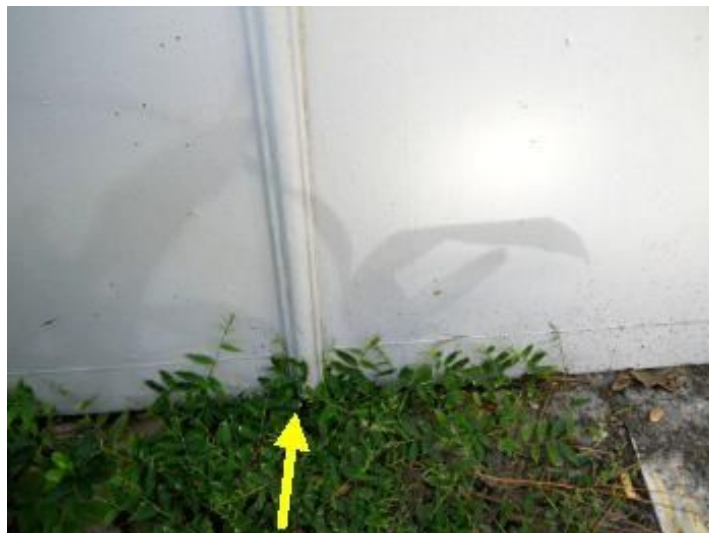
- 4.1. Siding to Soil contact or proximity. This may provide entrance of moisture or insects to siding. Recommend grading soil so there is at least 6" of space (where practical) between the siding and the soil below and checking for any damaged trim and siding materials.

Siding to soil contact

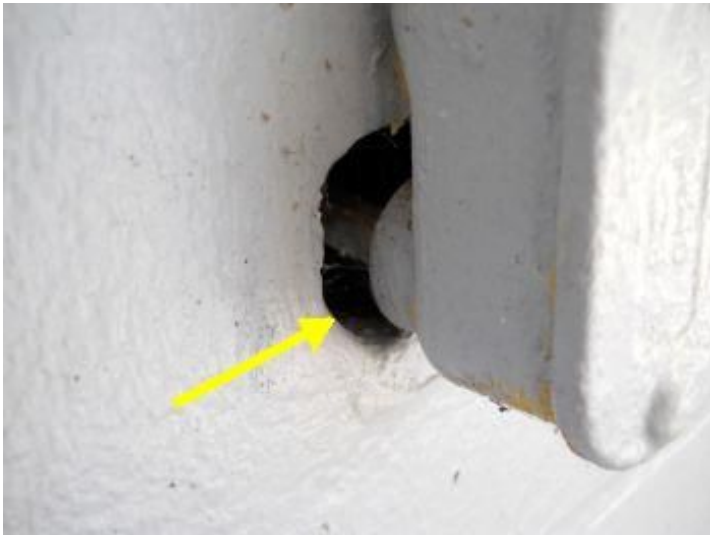
2.2. There are a few openings on the exterior walls. We recommend these be sealed as to prevent pest intrusion.

All exterior openings need sealing

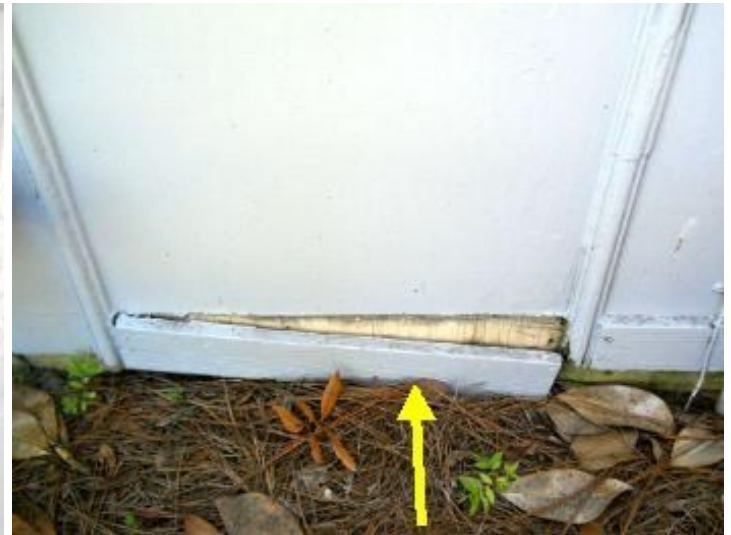
2.1. Loose trim board noted at west elevation

Loose trim West elevation

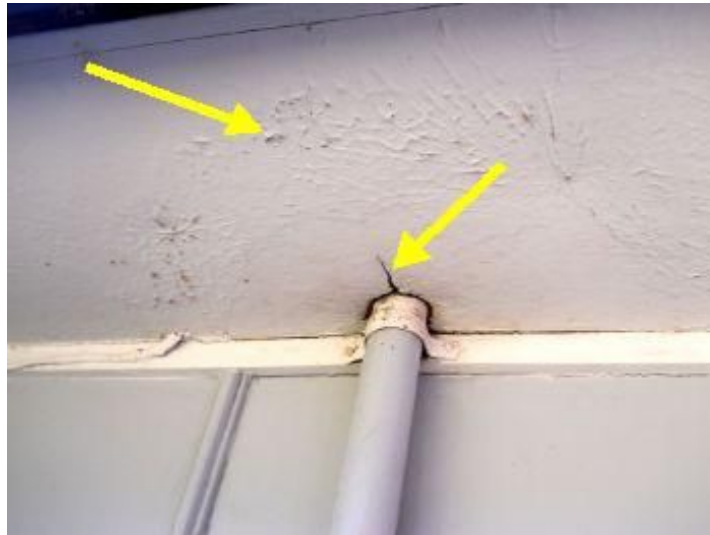
6.2. Minor moisture damage noted on west elevation at the power mast.

Moisture damage at power mast

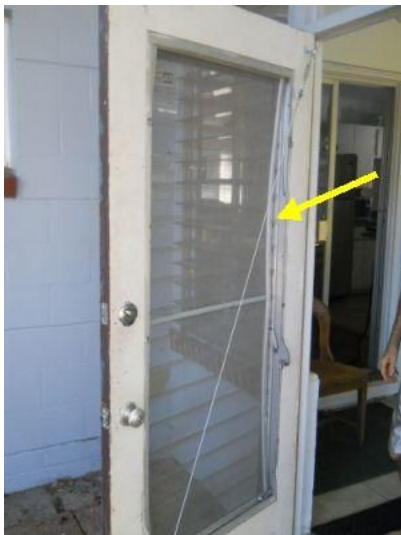
Florida room door screen damaged

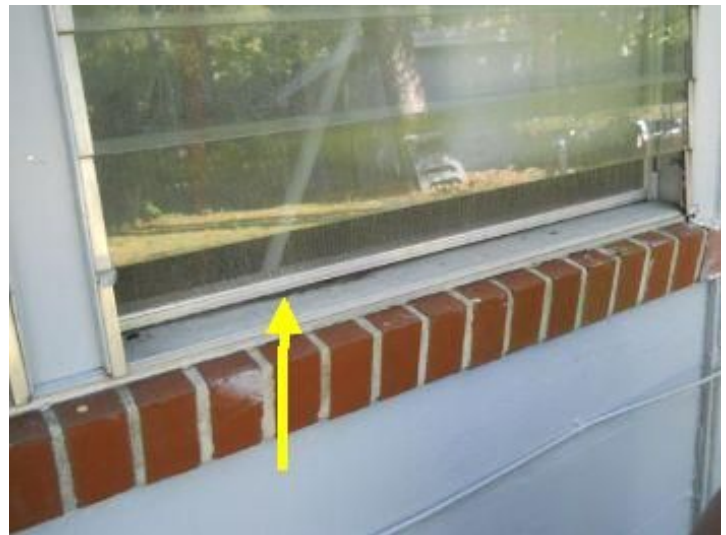
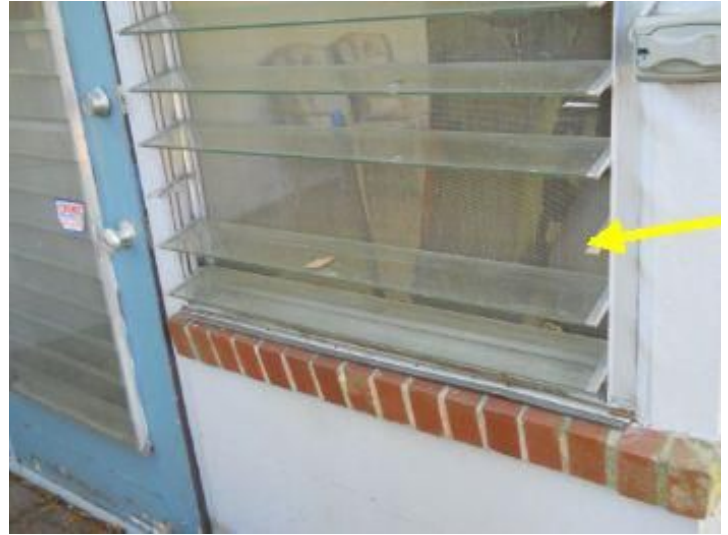
- 3.1. Windows units tested were in condition with any exceptions noted. Most windows need periodic adjustment or minor repair over time to work properly.
- 3.2. The main entry door appeared to be in satisfactory condition.
- 3.3. Interior doors were in satisfactory condition with any exceptions noted.
- 3.4. The sliding glass doors were all operational. Some will need minor adjustment/maintenance or repair to work properly. Periodic maintenance can be expected for the units to work smoothly.
- 3.5. Exterior door screen in the Florida room is damaged.
- 3.6. Master bath door is missing.
- 3.7. We noted two jalousie window panes were missing.

Two jalousie panes missing

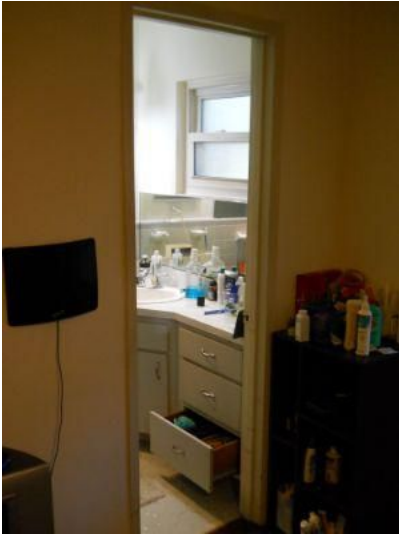
Master bath door missing

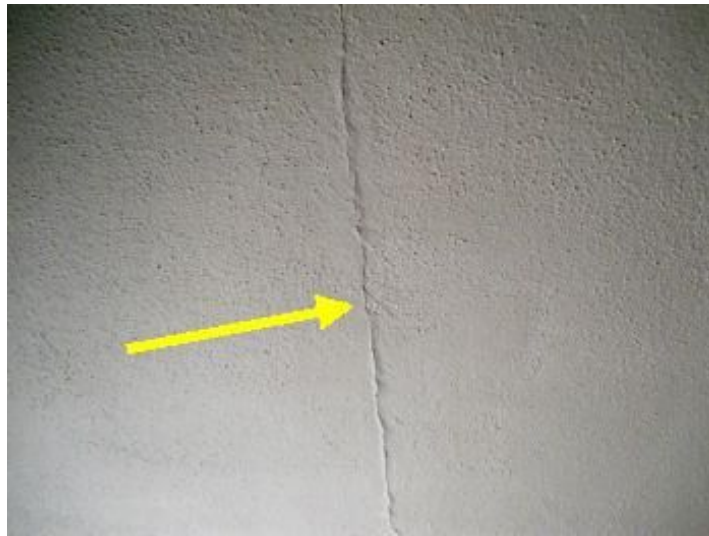
6.1. At the time of the inspection, we found minor damage and cracking on plaster ceilings in some areas. These can be repaired the next time any painting is done in these areas.

Minor ceiling damage/crack

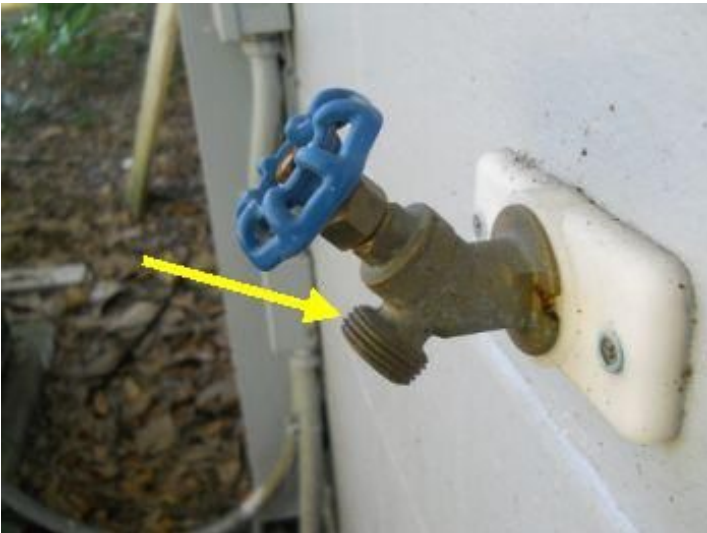
- 3.1. The hose bib(s) did not have **backflow prevention**. We recommend all outside bibs have backflow prevention as to prevent contamination of the potable water within the dwelling.

Hose bib(s) require back flow prevention

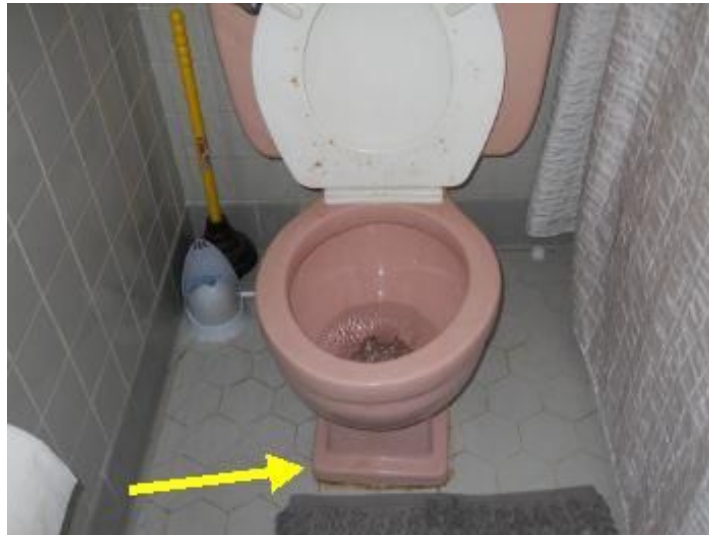
- 5.1. The Guest Bathroom toilet is loose at the floor.

Guest bath toilet loose at floor

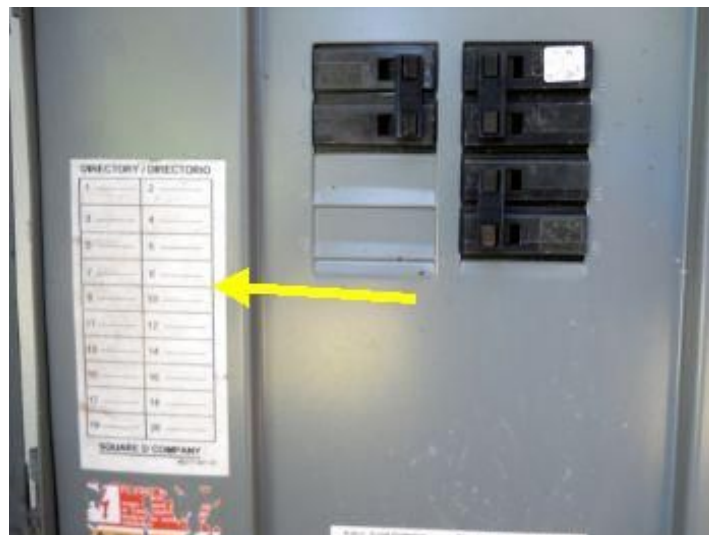
2.2. Breakers were not properly labeled. All breakers should be labeled to show their intended purpose.

Breakers need proper labeling

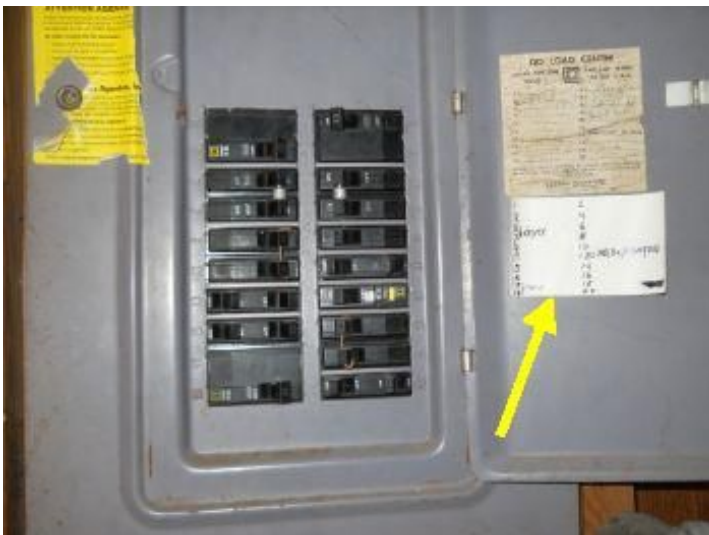
Breaker(s) need proper labeling

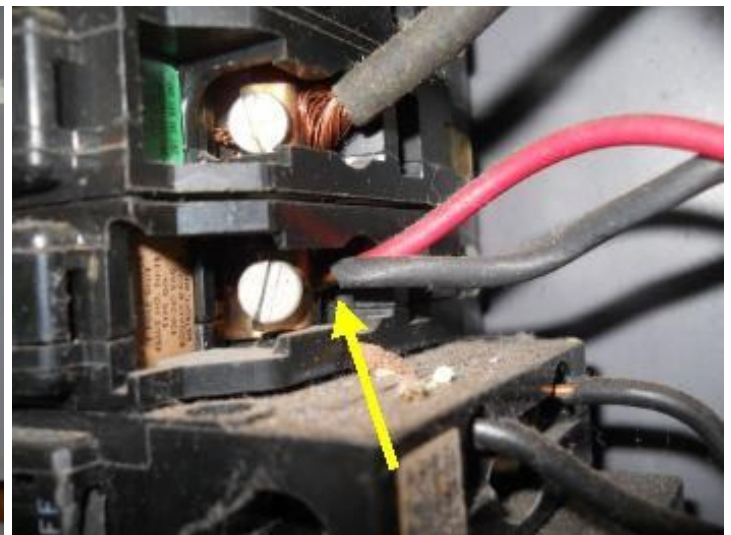
- 4.1. The breakers were not properly labeled. All breakers should be labeled to show their intended purpose.
- 4.2. Double tapped breaker(s) inside panel box (more than one electrical conductor attached). This is not standard practice, and may cause overheating or even an electrical fire. Recommend evaluation and repair by a licensed electrician.

Double tapped breaker(s)

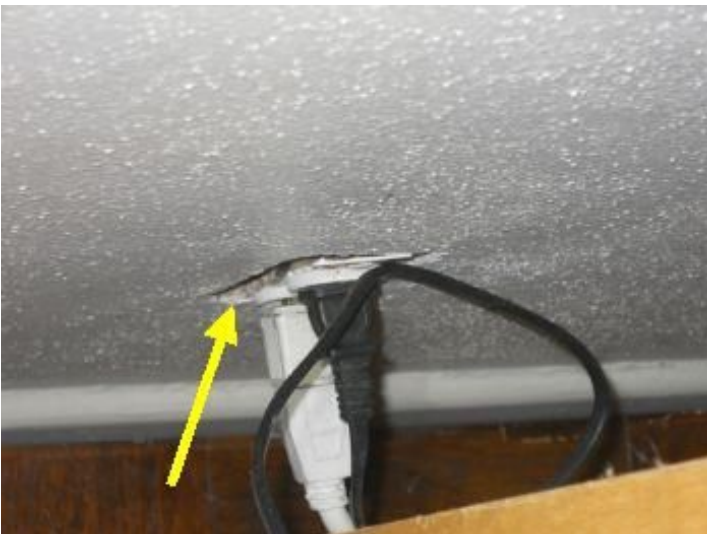
Bedroom #2 cover plate missing

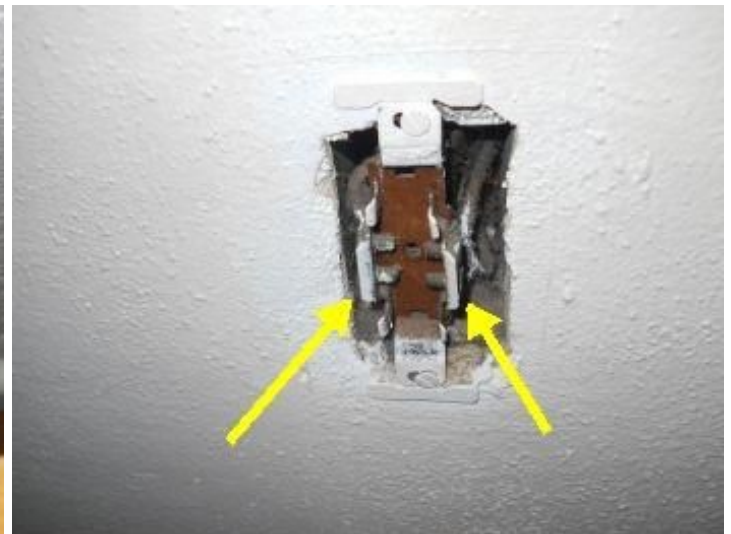
- 8.1. Outlet in bedroom #1 is damaged with exposed terminals. This is an electrocution/fire hazard. Recommend this be repaired ASAP.
- 8.2. A few cover plates were missing or cracked.
- 8.3. Dining room dimmer switch is damaged and in need of replacement.

Bedroom #1 outlet damaged... Electrocution hazard

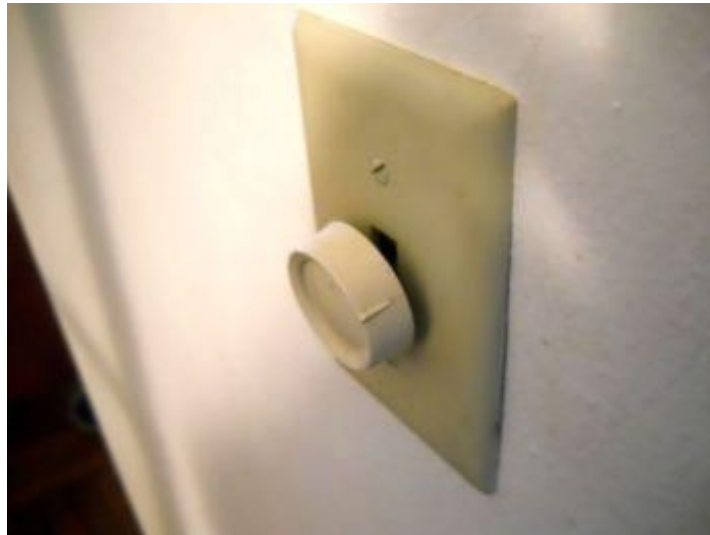
Dining room dimmer switch damaged

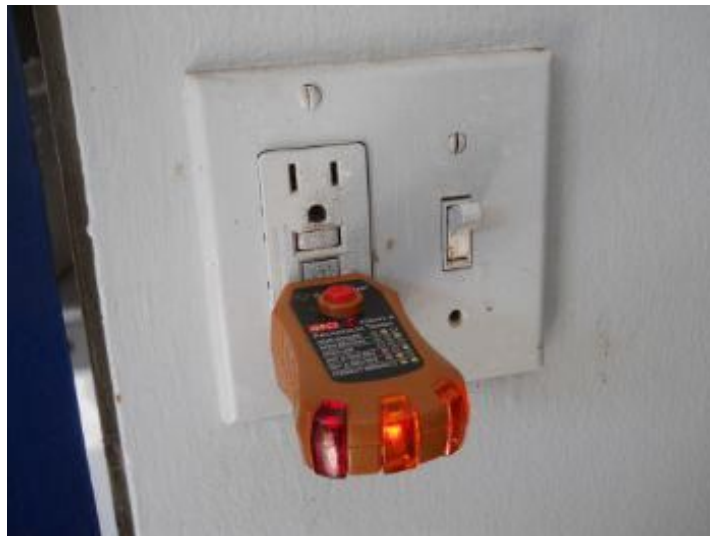
- 9.1. GFCI outlet on the carport would not trip when tested.
- 9.2. Outlet on the carport needs a weatherproof cover installed.

Carport GFCI outlet will not trip

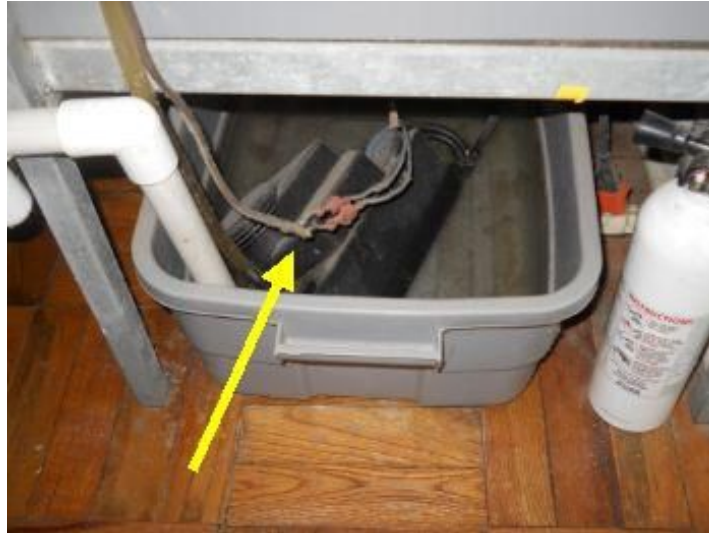
2.3. We noted the condensation drain pump at the **air handler** was not operating properly. The pump container was half full of water.

Air handler condensate pump inoperative

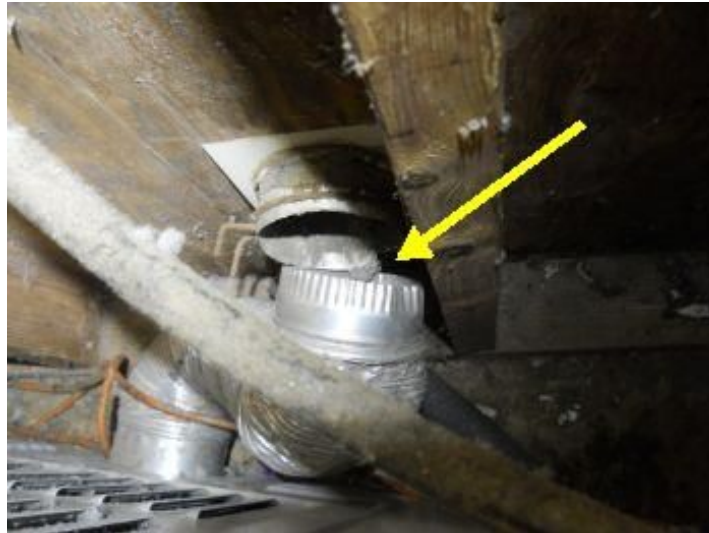
- 4.1. The clothes dryer duct was disconnected.

Clothes dryer duct loose

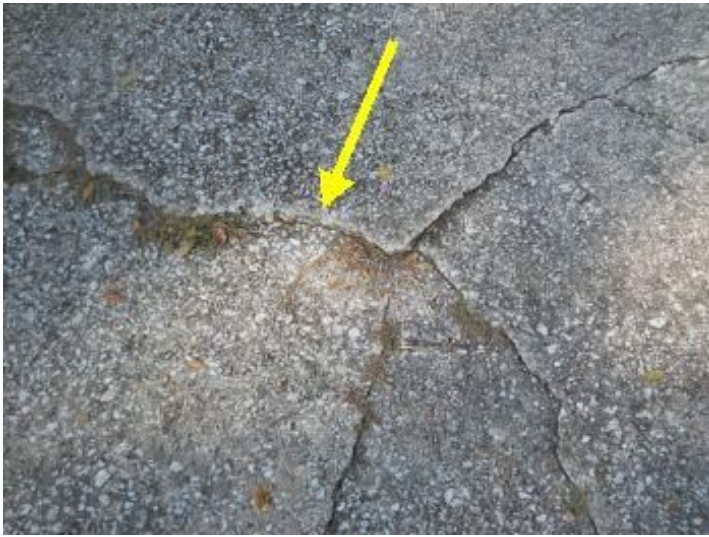
Extensive cracking at driveway

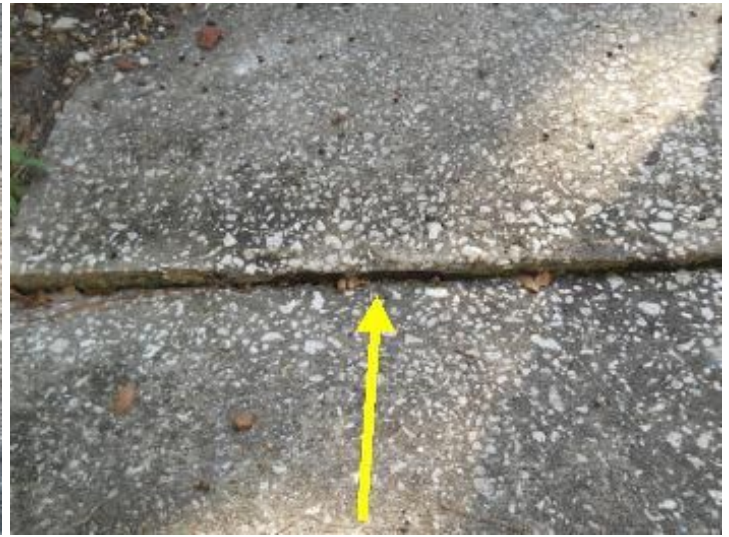
- 2.1. Extensive cracks in driveway. Repair and / or monitor for expansion and development of trip hazards.
- 2.2. Uneven slabs at the driveway. This is a potential tripping hazard. Recommend repair and or replacement of the displaced concrete.

Uneven slabs.... Tripping hazard at driveway

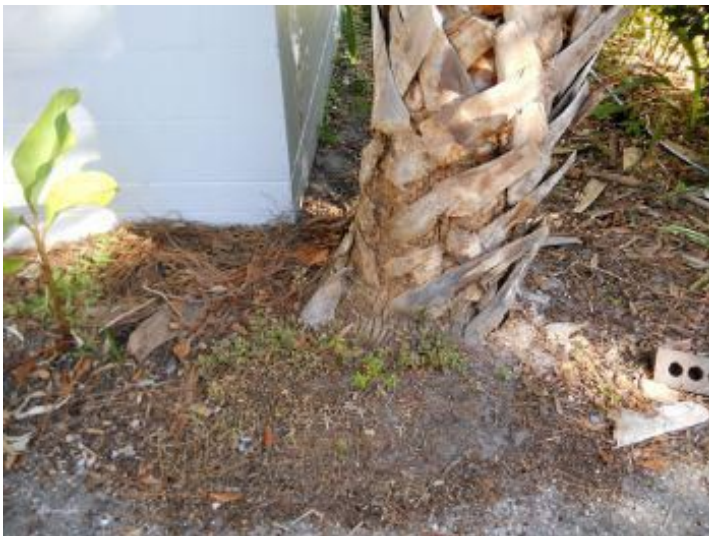
- 3.1. Trees are within 6 feet of foundation. Monitor for potential root damage.
- 3.2. Tree branches overhanging roof and/or against siding. Trim trees that are in contact or proximity to home, as branches can abrade siding and damage roofing.

Tree close to the foundation

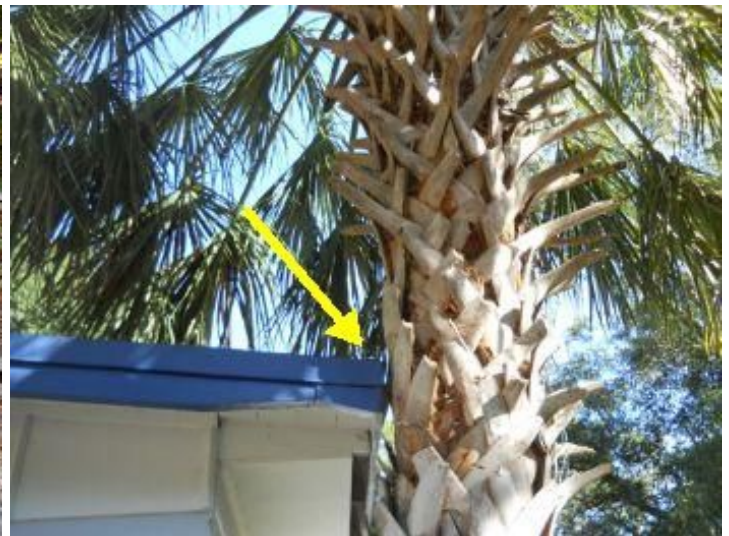
Tree close to the fascia
