1st Inspection Svcs

Home Inspection Report

123 Tester Drive, Palatka, FL 32177
Inspection prepared for: Test Demo
Date of Inspection: 10/14/2019 Time: 10:00
Year Built: Circa 1958 Size: 1540
Weather: Fair

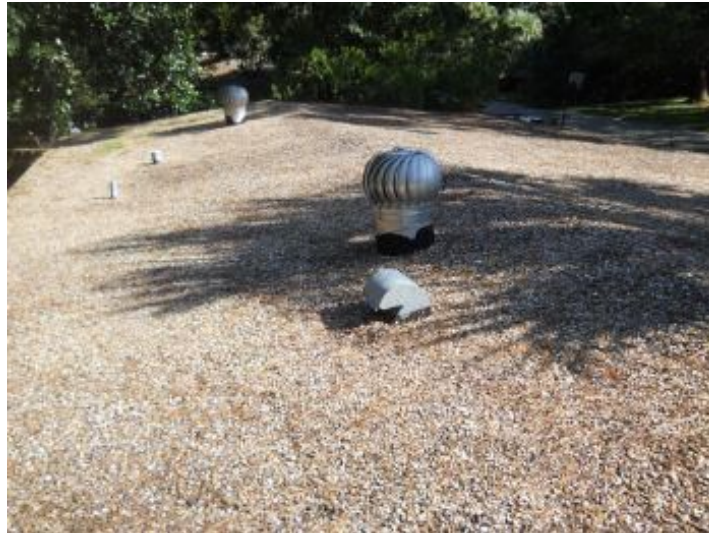
- At the time of this inspection we found all roofing to be in satisfactory overall condition.
- Over the structure is a gravel built up roof. This type of roof is typically constructed by hot-mopping several (3-5) plies of fiberglass/asphalt composition felt layers over a base sheet, then installing the gravel to protect the plies from the elements.
- The average life expectancy for this type of roof is 25 years in Florida. This roof appears to be 15-20 years old.

Gravel built up roof

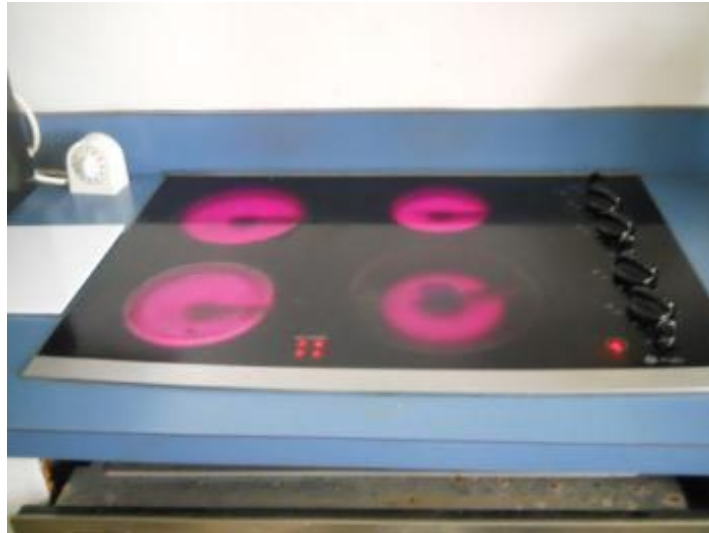
Cooktop

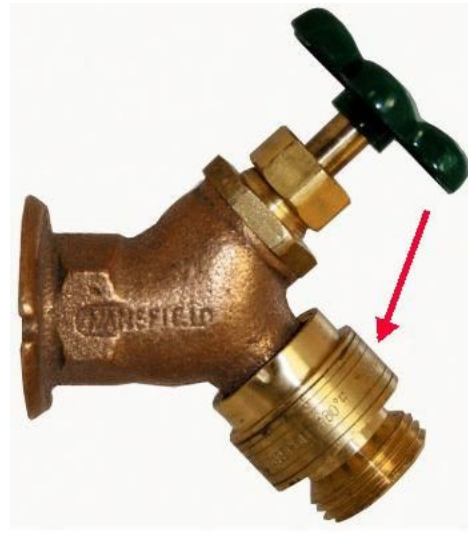
Hose bib(s) require back flow prevention

Back flow prevention example

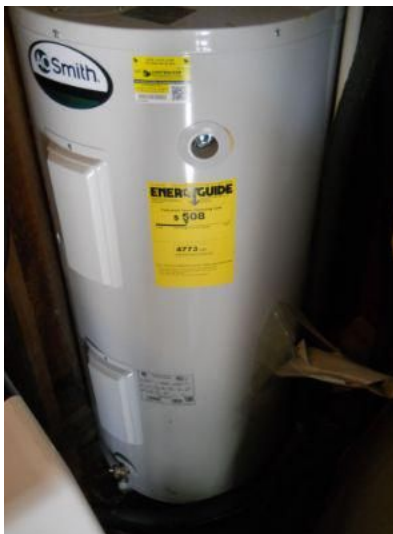
- The water heater was in satisfactory condition at the time of inspection.
- The 2013 AO Smith 40-gallon water heater appeared to be operating properly at the time of the inspection.
- The average life expectancy of a water heater is approximately 15-25 years. Water heaters generally need not be replaced unless they leak.
- According to present day requirements, water heaters should have a **pressure relief valve** and drain line which flows by gravity to the exterior, or downward to within 6 inches of the structure floor. The size of the drain line should match the outlet size of the relief valve, and an auxiliary pan with a 1" drain line, which drains to the exterior is required underneath when the unit is installed at or above the level of the living area.
- This unit was properly equipped.

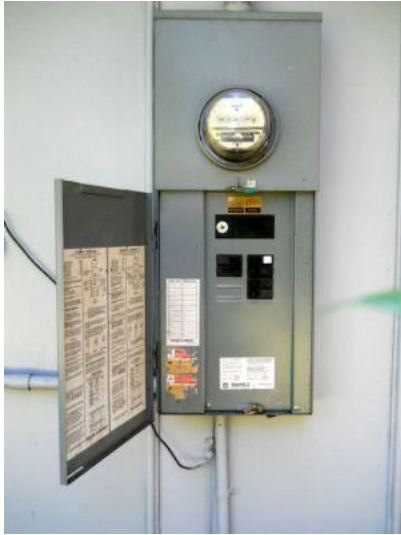
- We inspected the circuitry in the Square D 200 amp 240-volt service main panel located in the exterior west wall .
- The service main panel is equipped with copper branch wiring.
- There is an overhead service drop noted.
- The service main has an earth ground. The termination of the main ground wire for the electrical service was not accessible.
- In our opinion, the existing service main capacity is sufficient for the current electrical demand of the structure.

Square D 200 amp service main

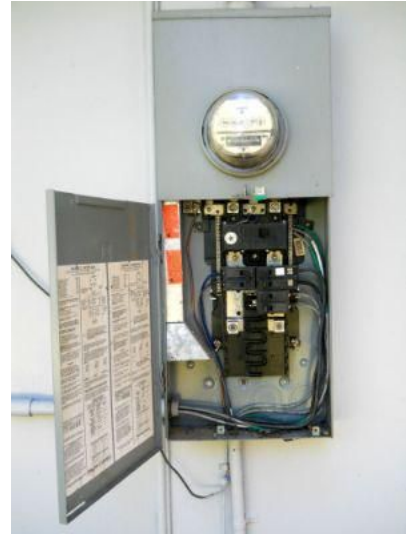
Square D 200 amp service main open for inspection

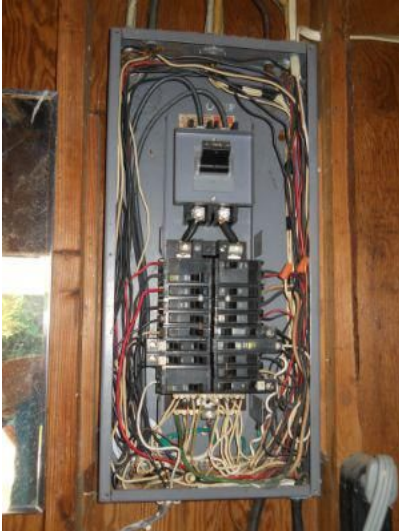
- We inspected the circuitry in the Square D 100 amp 240-volt service sub panel located in the utility room .
- The sub service entry conductor material is copper .
- The panel is equipped with copper branch wiring.
- In our opinion, the existing sub service capacity is sufficient for the current electrical demand of the structure.

Square D 100 amp service sub open for inspection

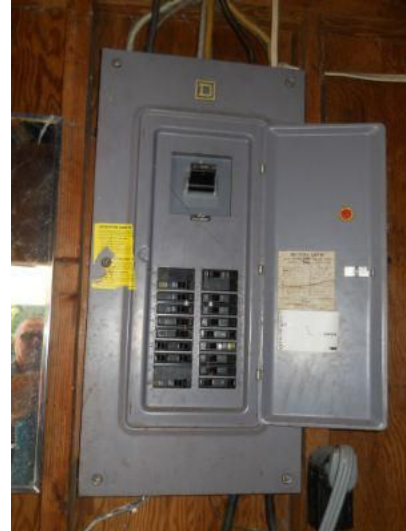
Square D 100 amp service sub

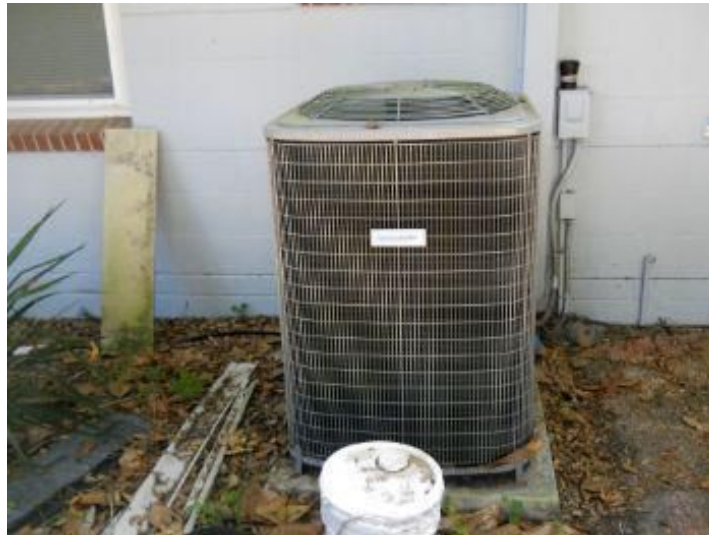
1.1. The home is equipped with a 2007 International Comfort Products 2-1/2-ton electric, forced air **heat pump** system.

2007 I.C.P. 2-1/2 ton heat pump

1.2. Outside units should be serviced at least once a year. Outside units have a normal life expectancy of 10-15 years.

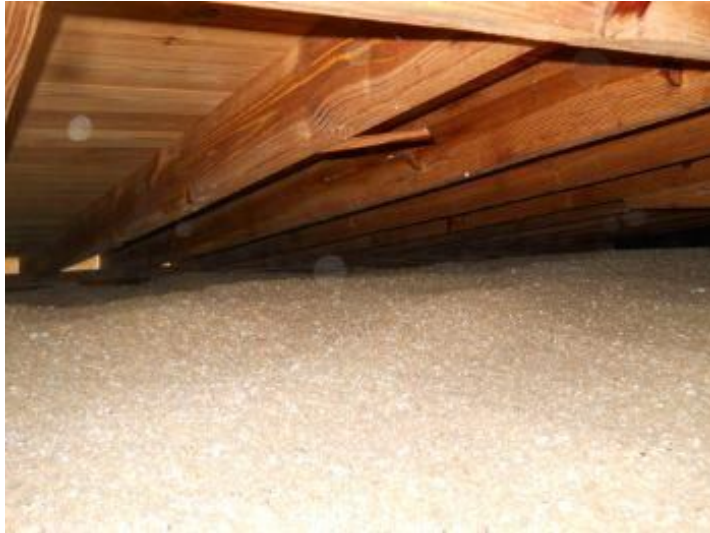
- At the time of this inspection we found the insulation to be in satisfactory condition with any exceptions noted.
- The attic area over the main structure was insulated to an average depth of 10-15 inches.

Insulation average depth 10-15 inches

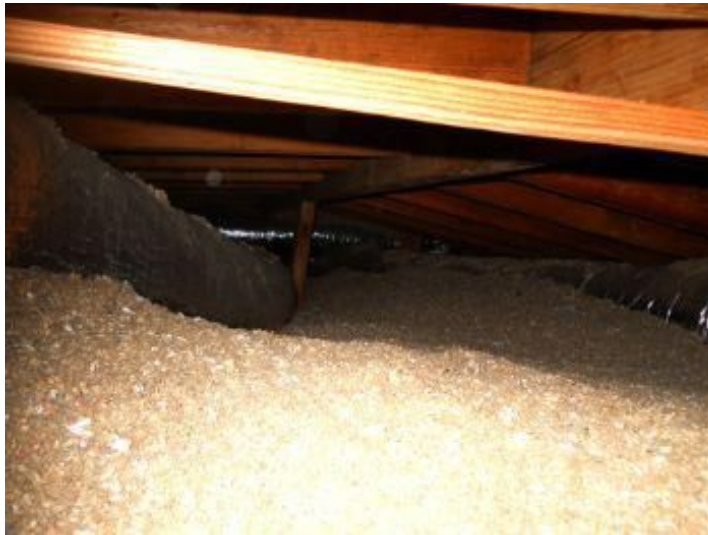
- The attic access opening is located in the dining room. The roof and ceiling structure was visually inspected by physically crawling through the accessible attic area. A portion of the attic was not accessible due to framing, insulation, HVAC equipment, etc. Insulation was not moved.
- The visually accessible attic framing was found to have a customary and workmanlike appearance. The conventionally framed attic system appeared to be adequate to carry the current roof load. We found no evidence to indicate rafter or joist failure.

Attic area
